Pretreatment Compliance Inspection

Summary Report

Discharger: City of North Las Vegas
NPDES Permit No. NV0023647

Inspection Dates: September 29–30, 2014

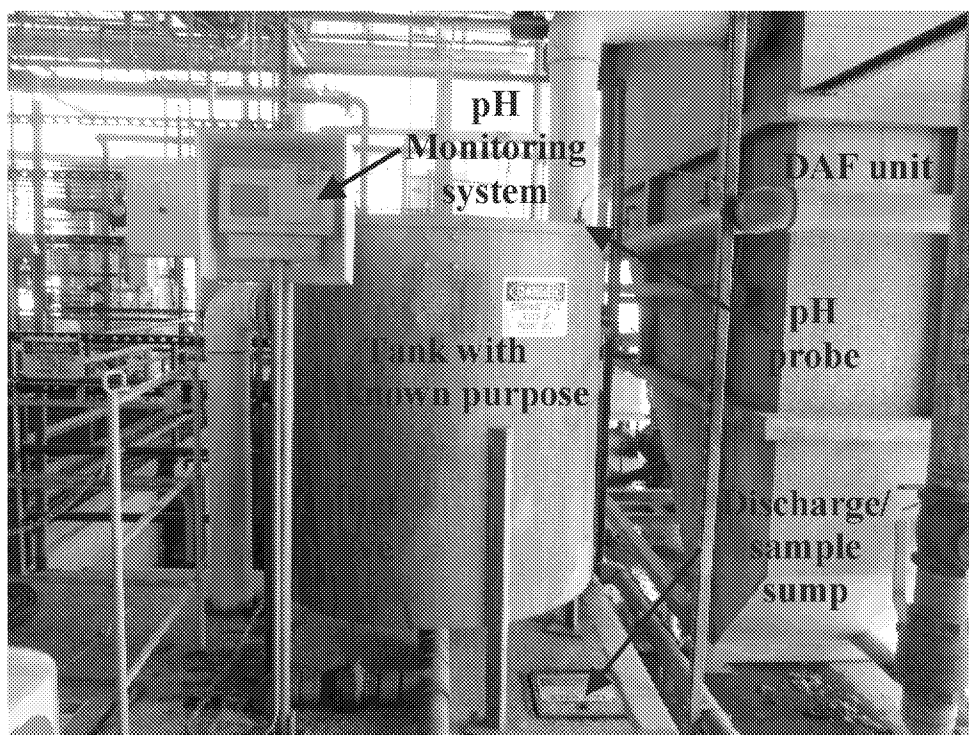
Photograph 1. View of the unlabeled tank, pH monitoring system, and pH probe located adjacent to the DAF unit and discharge/sample sump. The pH monitoring system was inoperable at the time of the inspection. Note the unknown tank's outlet pipe valve.

- It is recommended that the City conduct a followup inspection at the CINTAS Corporation facility to determine the facility's need to reinstall the pH monitoring system to conduct continuous pH monitoring and ultimately ensure that the wastewater is within the permitted pH range. In addition, it is recommended that the City inspectors become familiar with the CINTAS Corporation facility's pretreatment system and that the City recommend the facility develop written standard operating procedures (SOPs) for operating the pretreatment system in the event that Decon Water Technologies, LLC is unavailable. Furthermore, it is recommended that the City conduct a followup inspection

The facility does not perform continuous pH monitoring of its wastewater effluent. The EPA Inspection Team observed a pH probe and monitoring system near the unlabeled tank and discharge/sample sump; however, it was not working at the time of the inspection (refer to Photograph 1 of the CINTAS Corporation Photograph Log).

The Production Manager stated that the facility does not conduct continuous pH monitoring of the facility's discharge. The EPA Inspection Team observed a pH probe and a monitoring system control box; however, the system was inoperable at the time of the inspection (refer to Photograph 1 of the CINTAS Corporation Photograph Log). In addition, a tank with an unknown purpose was observed between the DAF unit and the facility's discharge/sample sump. The facility representatives were unaware of the purpose of the tank. Effluent from the DAF passed through the tank before entering the discharge/sample sump.

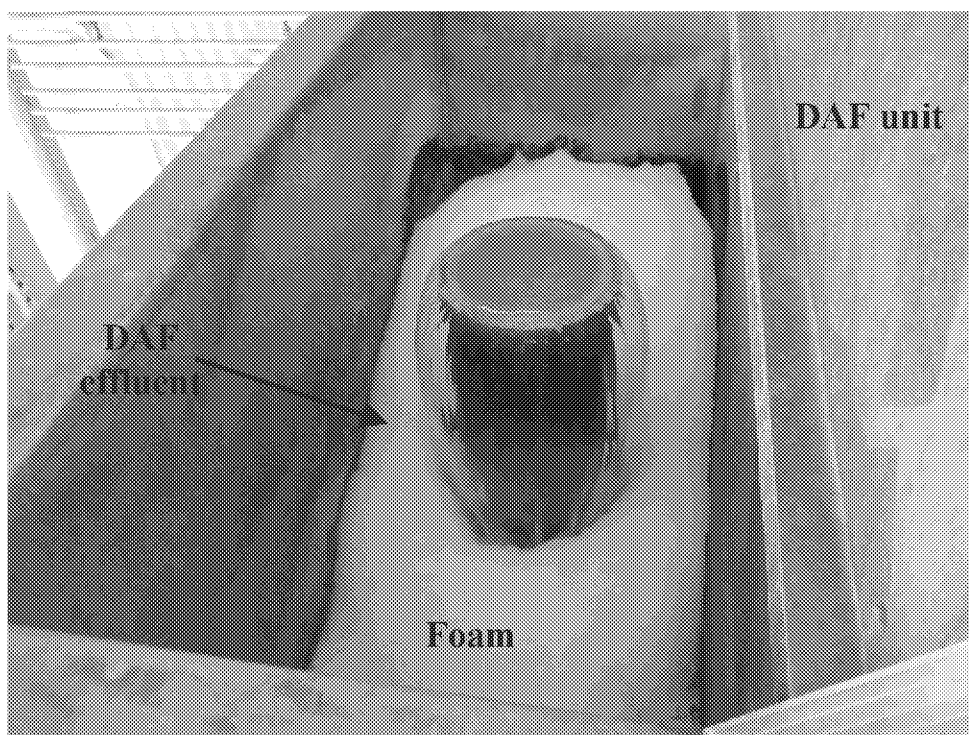
Photograph 2. View of foam accumulation at the DAF unit effluent discharge point. The facility's pretreatment system shift operator stated that foam was very common in here and in the discharge/sample sump due to the addition of flocculant to the wastewater, prior to the DAF unit.

The EPA Inspection Team observed a large amount of foam at two locations: the effluent point from the DAF unit and within the discharge/sample sump (refer to Photographs 2 and 3 of the CINTAS Corporation Photograph Log). The facility's pretreatment operator present at the time of the inspection stated that foam is very common in both the DAF unit and within the discharge/sample sump due to the flocculent that is added to the wastewater upstream of the DAF unit. The facility does not conduct continuous pH monitoring; therefore, the EPA Inspection Team was unable to verify whether the foam accumulated was influencing the pH of the facility's discharge. It is recommended that the City conduct a followup inspection to determine the facility's need to reinstall the pH

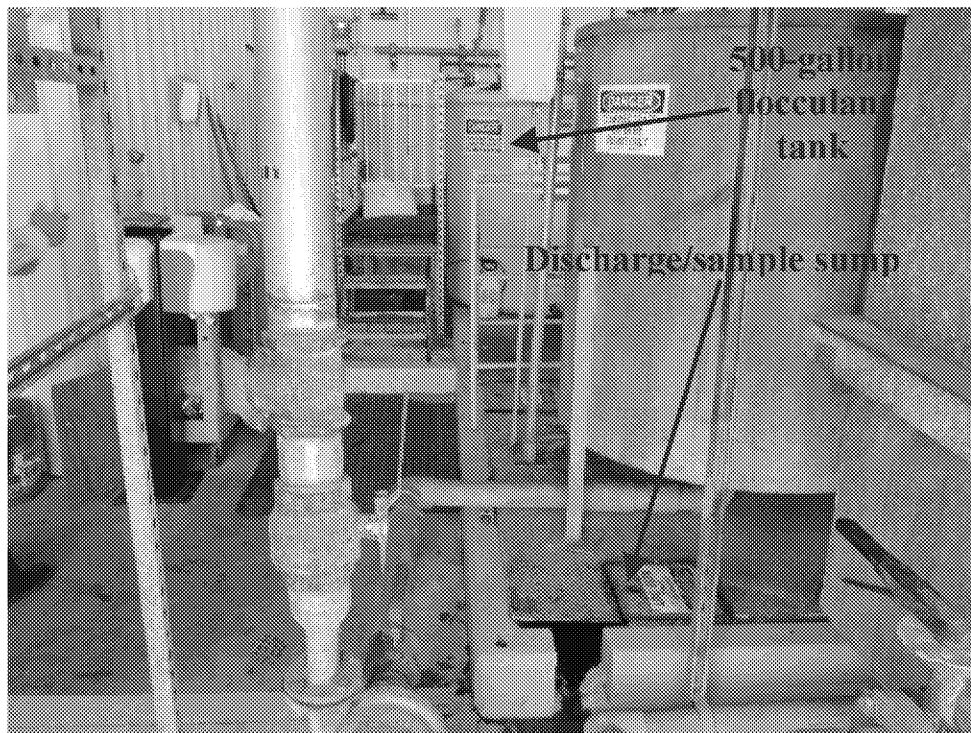
Photograph 4. View of the single-walled, 500-gallon flocculant tank stored immediately adjacent to the facility's discharge/sample sump. Note the tank was not in secondary containment.

The EPA Inspection Team observed that the 500-gallon tank of flocculant was stored immediately up gradient of the facility's discharge/sample sump. The flocculant tank was single-walled and was not located in a secondary containment structure (refer to Photographs 4 and 5 of the CINTAS Corporation Photograph Log). In the event of a spill or leak, flocculant could potentially enter the discharge/sample sump and discharge directly to the City via the open discharge pipe. Part II, Monitoring and Reporting, Item L, Spill Containment Systems, of the facility's expired Class I Wastewater Control Permit states, "Secondary containment is required for all petroleum and chemical products in containers greater than five gallons." Therefore, the City is required to ensure that the facility store the 500-gallon tank of flocculant inside secondary containment in accordance with Part II, Item L of the permit. It is also recommended that the City conduct a follow-up inspection to ensure that chemicals are properly stored, and not within the direct vicinity of the facility's discharge/sample sump.

7. The EPA Inspection Team observed that the 500-gallon tank of flocculent was stored immediately up gradient of the facility's discharge/sample sump. The flocculent tank was single-walled and was not located in a secondary containment structure (refer to Photographs 4 and 5 in the CINTAS Corporation Photograph log). In the event of a spill or leak, flocculent could potentially enter the discharge/sample sump and discharge directly to the City via the open discharge pipe. Part II, Monitoring and Reporting, Item L, Spill Containment Systems, of the facility's expired Class I Wastewater Control Permit states, "Secondary containment is required for all petroleum and chemical products in containers greater than five gallons." Therefore, the City is required to ensure that the facility store the 500-gallon tank of flocculent inside secondary containment in accordance with Part II, Item L of the permit. It is also recommended that the City conduct a follow-up inspection to ensure that chemicals are properly stored, and not within the direct vicinity of the facility's discharge/sample sump.

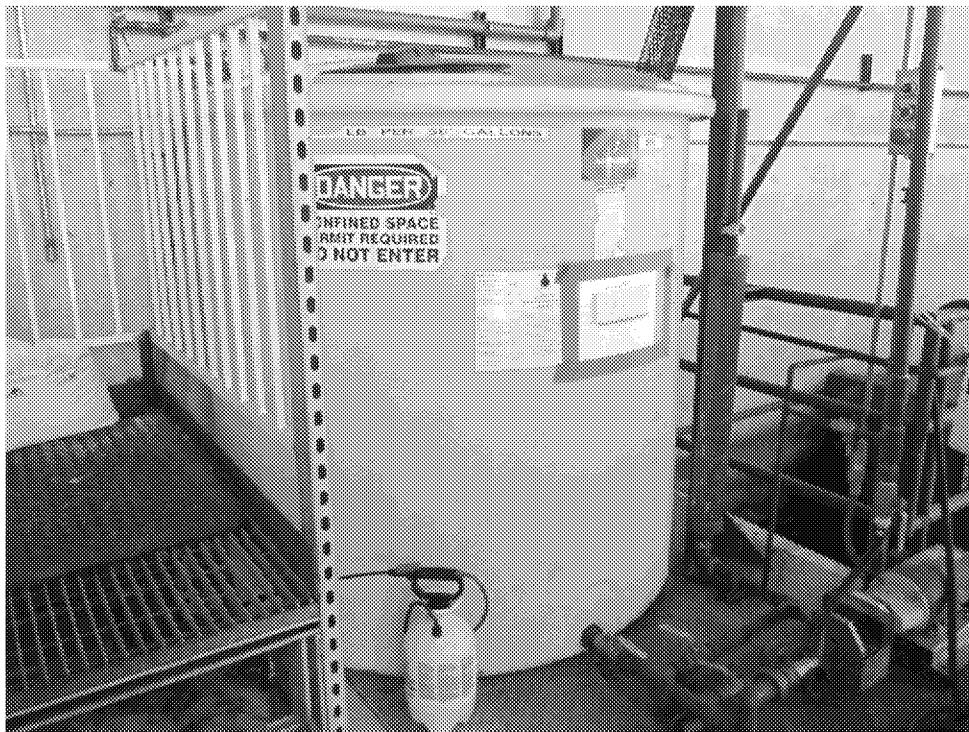
Photograph 5. Close-up view of the single-walled, 500-gallon flocculant tank, shown in Photograph 4, stored immediately adjacent to the facility's discharge/sample sump. Note the tank was not in secondary containment.

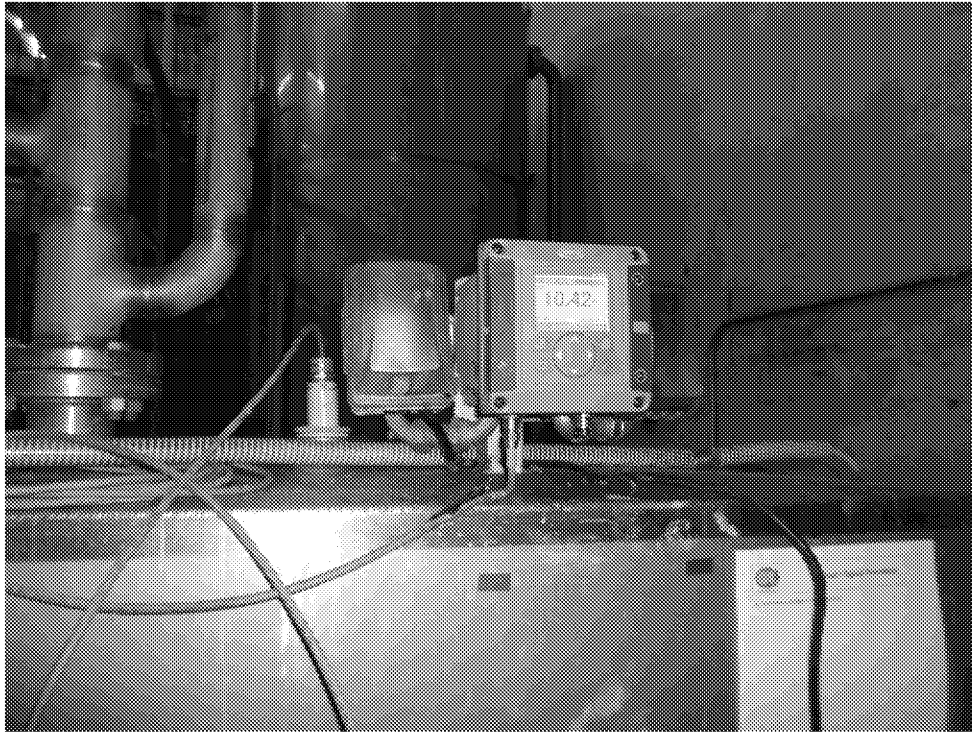
Photograph 1. Digital pH monitor for wastewater being discharged to the sanitary sewer. The meter was reading a pH of 10.42 standard units at this time of the inspection.

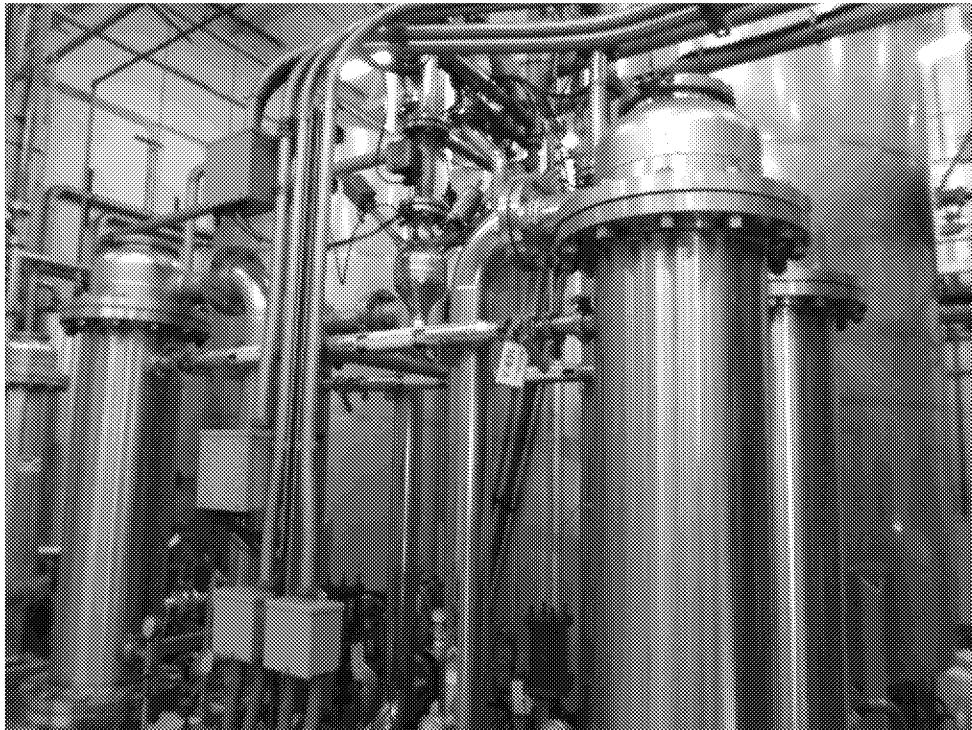
Photograph 2. View of the high pressure filters supporting the operation of the water treatment and reuse system.

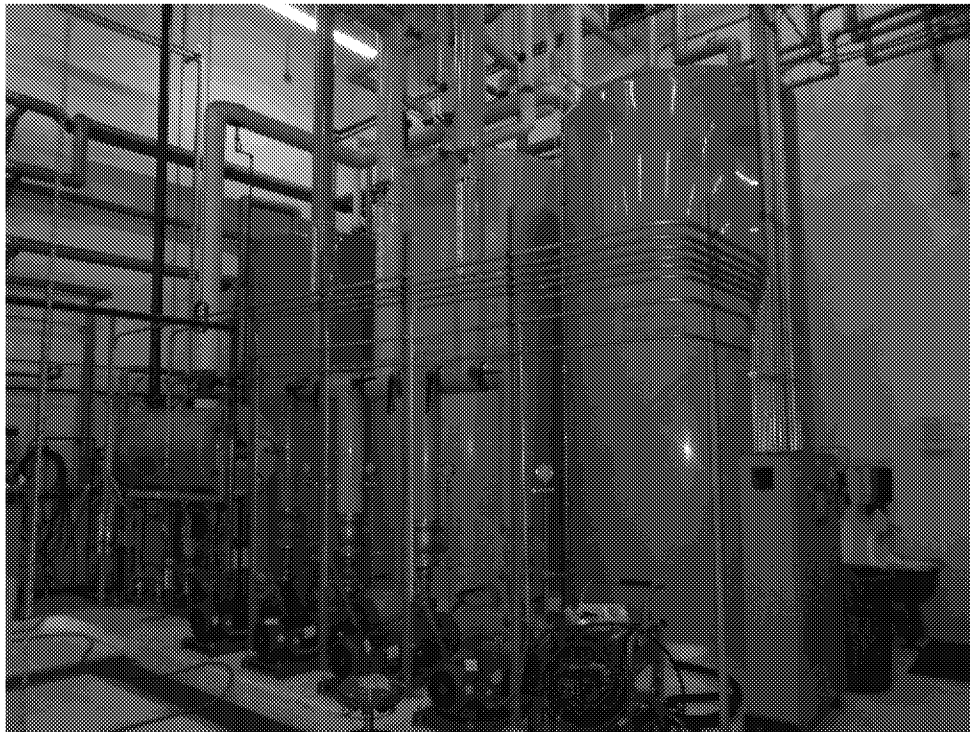
Photograph 3. View of the storage tanks supporting the operation of the water treatment and reuse system.

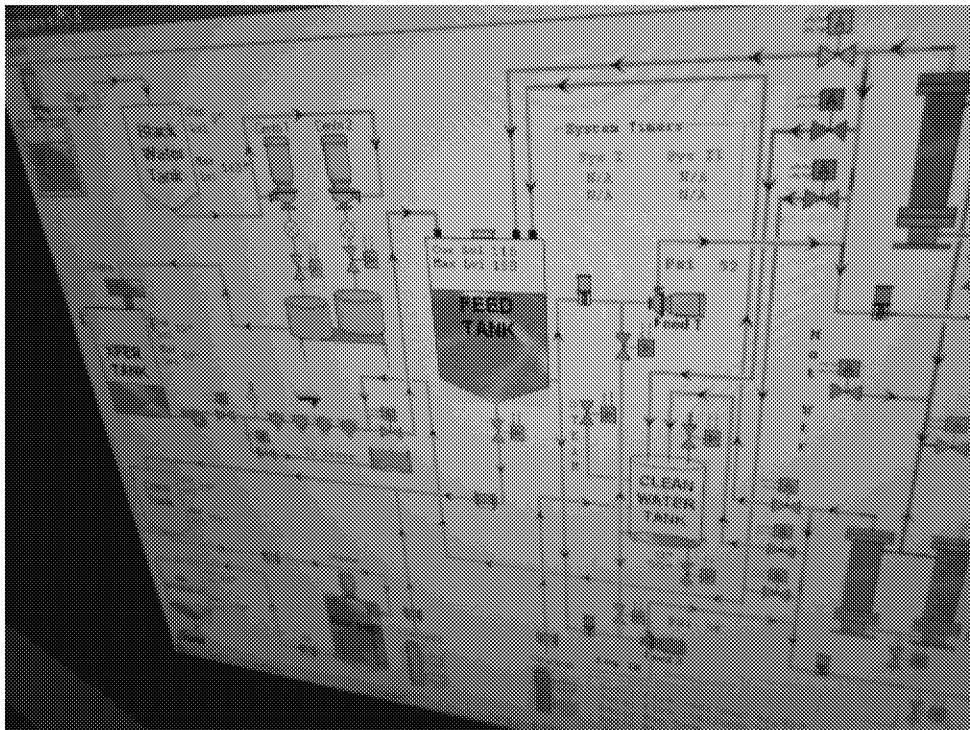
Photograph 4. View of the SCADA screen for the operation of the water treatment and reuse system.

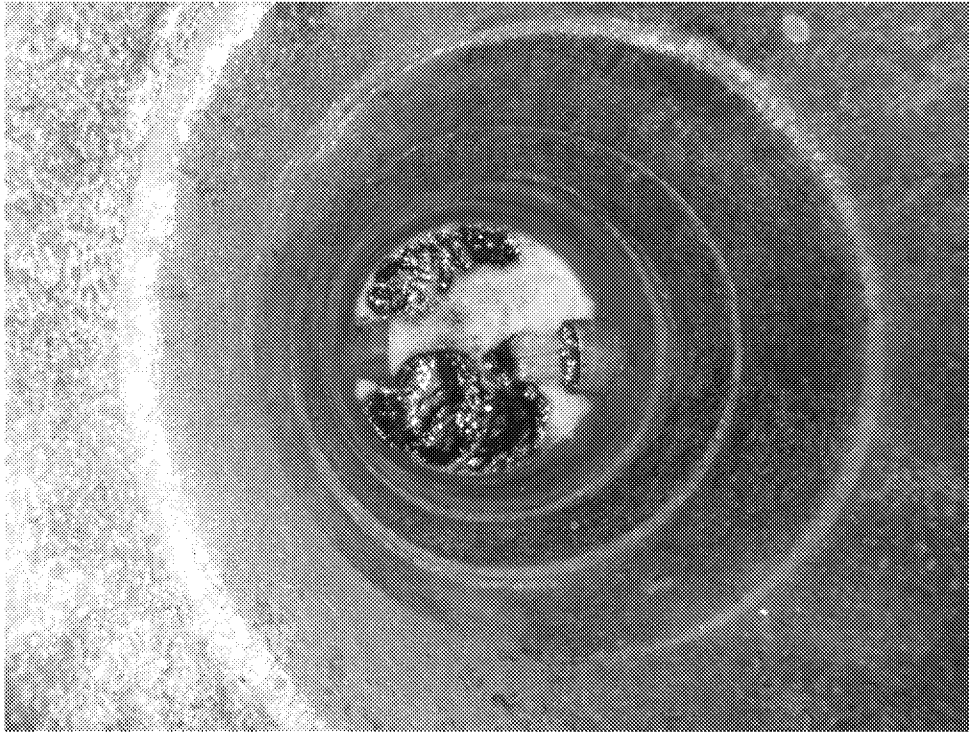
Photograph 5. View of the final discharge and sampling location at the facility's outfall. The discharge had a light brown hue in comparison to the white foam.

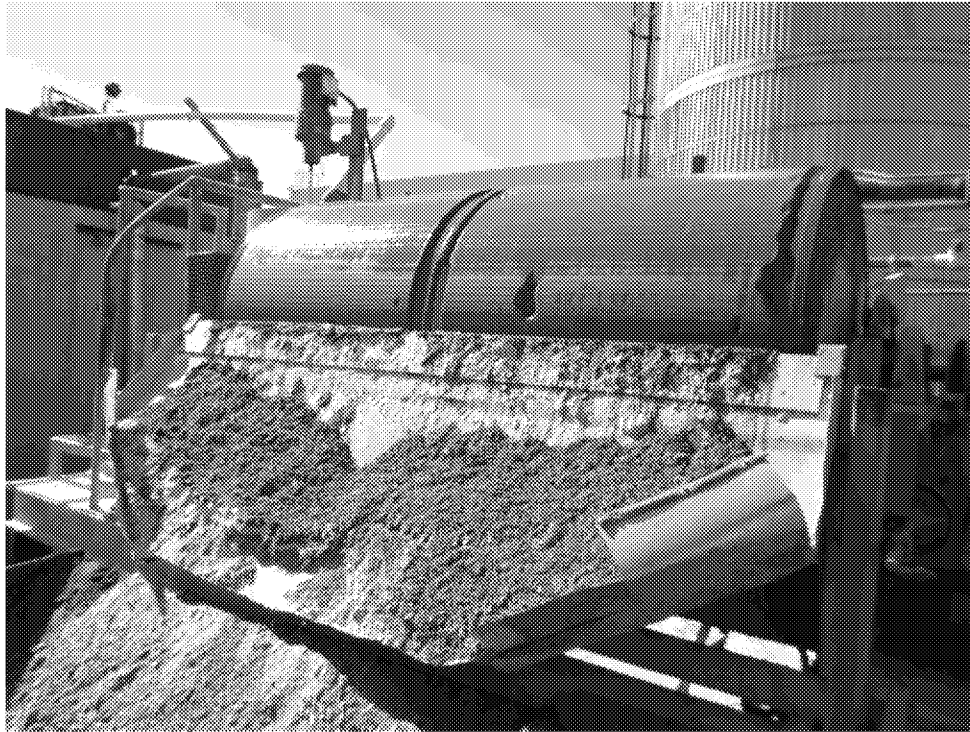
Photograph 1. View of the current ALAR filter unit that has replaced facility's DAF unit. The ALAR filter was not depicted on the schematic of the facility's brown grease processing area.

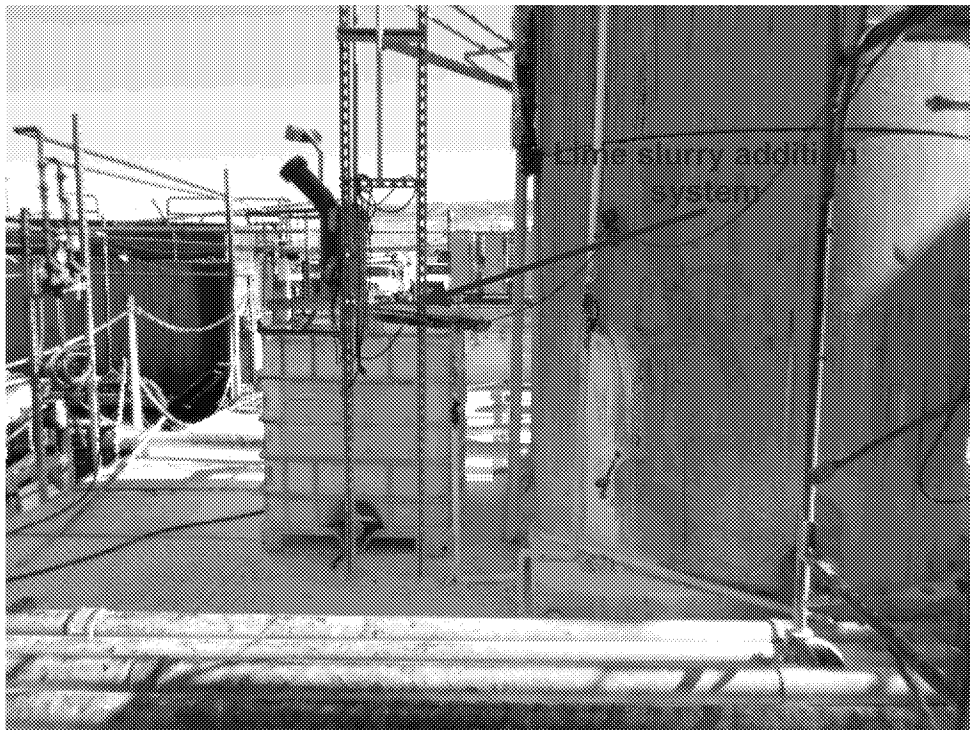
Photograph 2. View of lime slurry addition system, which was not depicted on the schematic diagram of the facility's brown grease processing area.

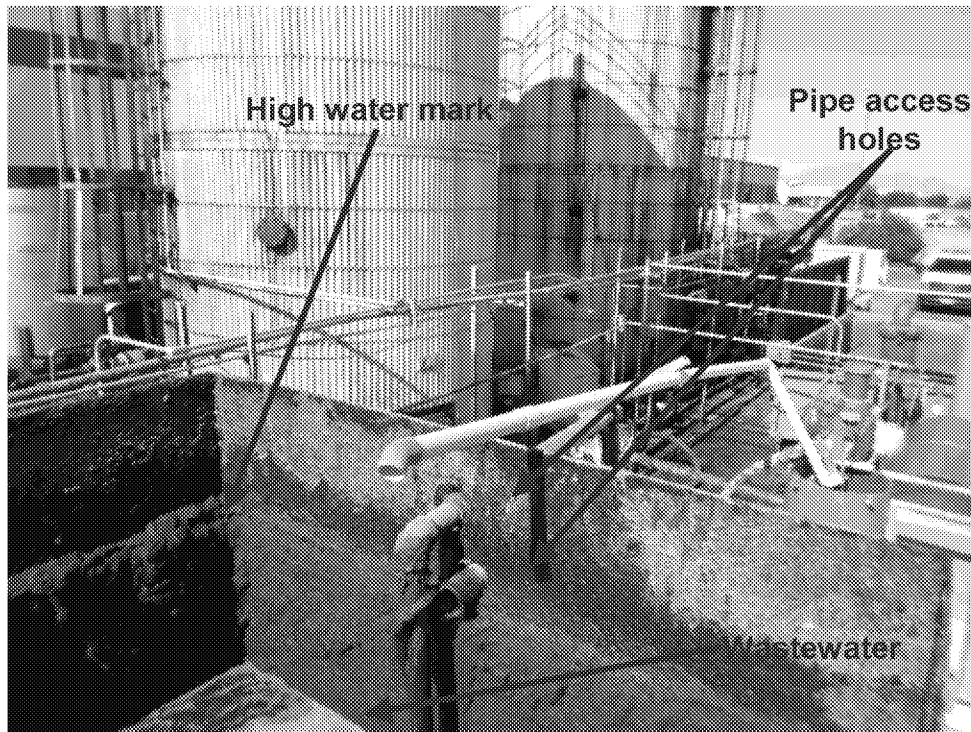
Photograph 3. View of grease interceptor wastewater level, influent pipe from the ALAR unit, and pipe access holes at the high water mark of the grease interceptor.

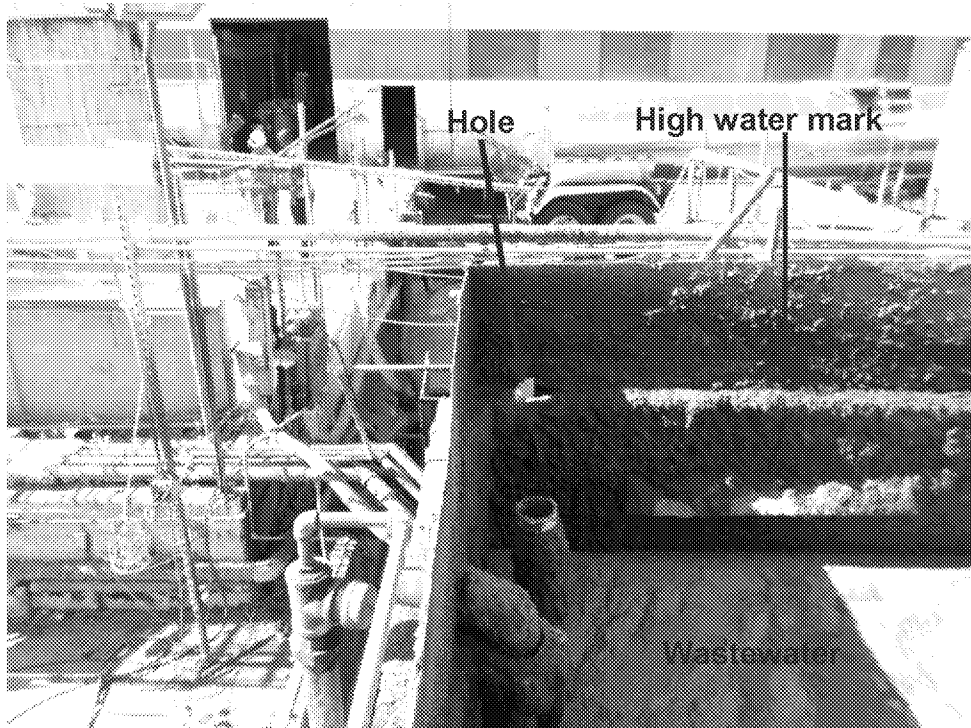
Photograph 4. View of grease interceptor wastewater level and a hole at the high water mark at the facility's grease interceptor.

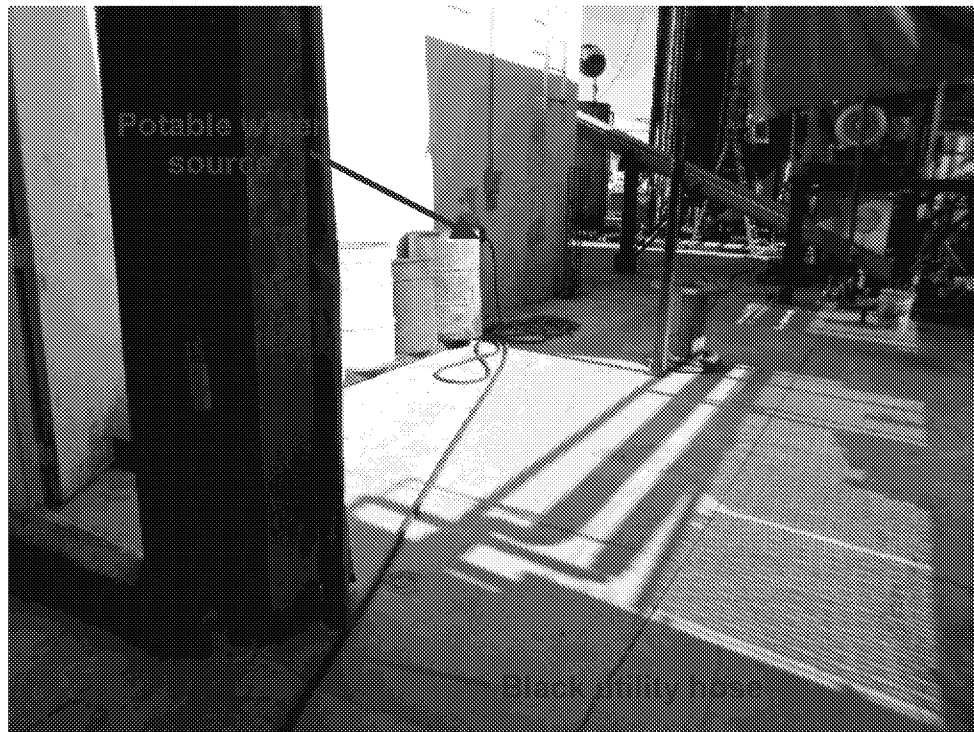
Photograph 5. View of the black utility hose connected to the portable water hose tap, leading into the boiler room.

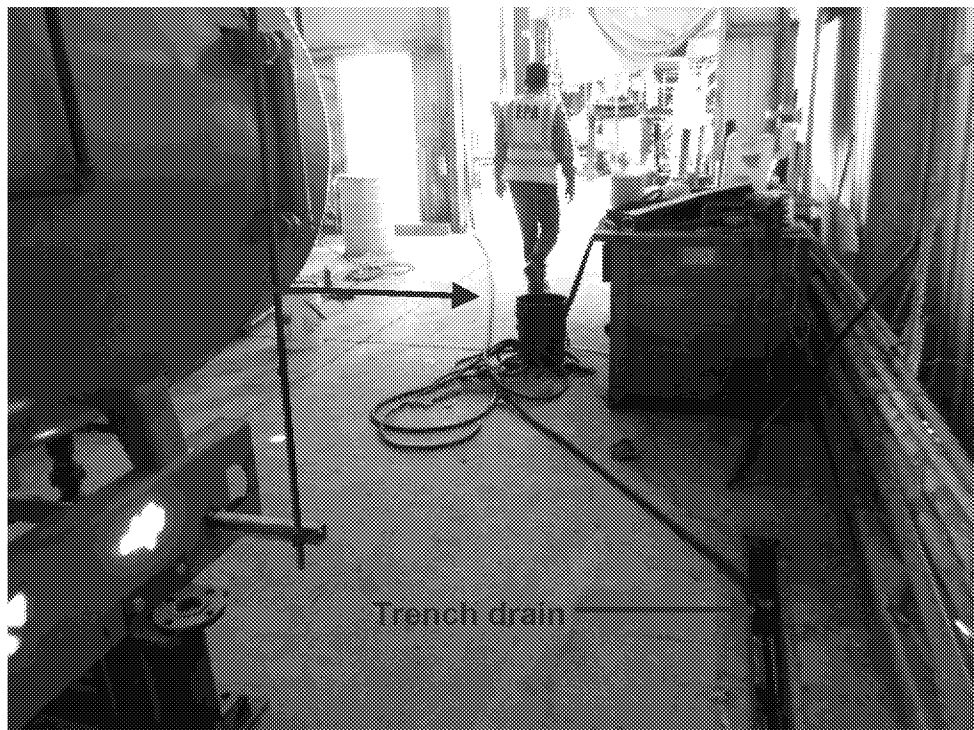
Photograph 6. View of the black utility hose running into the boiler room trench drain.

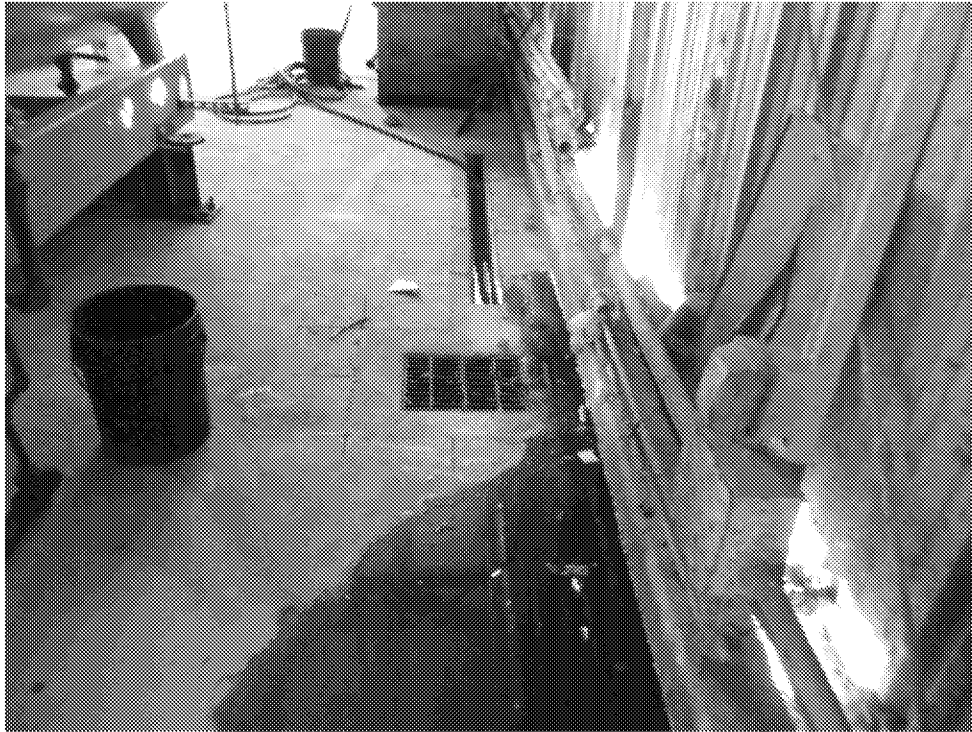
Photograph 7. Close-up view of the boiler room floor trench and drain. A black utility hose was found running in the floor trench, as depicted in Photograph 6, above.

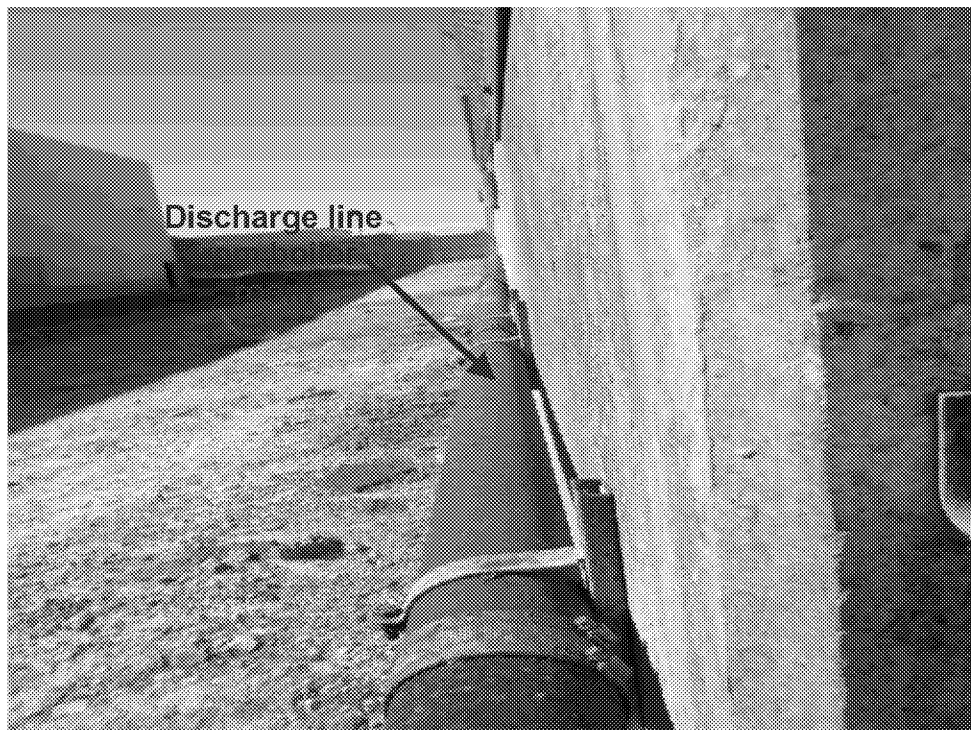
Photograph 8. View of the discharge line following the perimeter of the exterior edge of the property from the facility's boiler room.

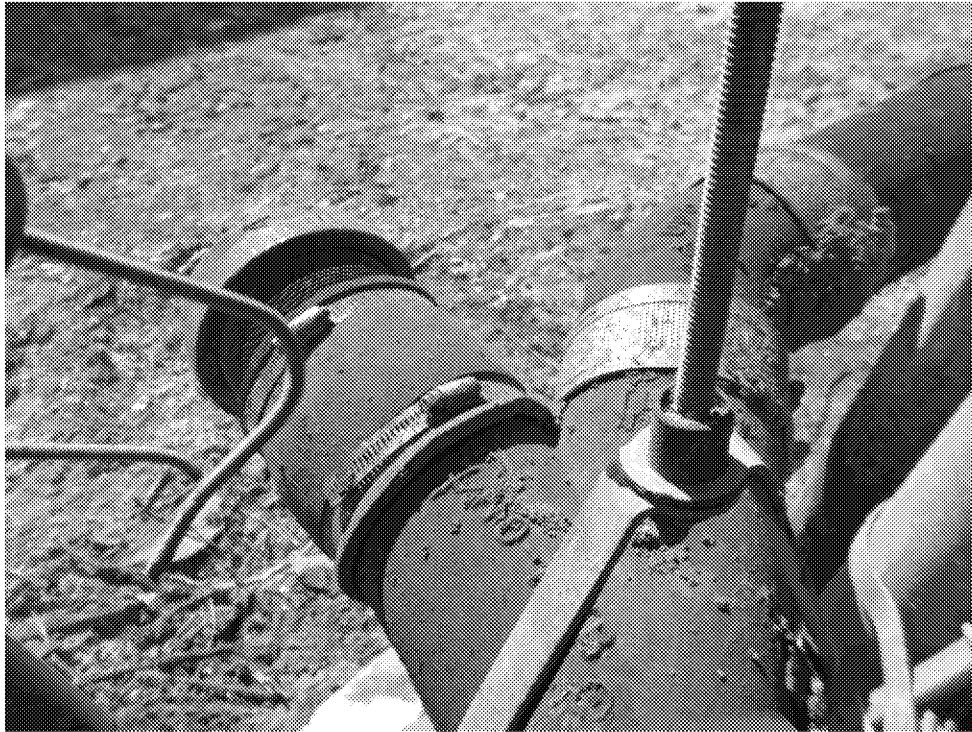
Photograph 9. View of the discharge line following the perimeter of the process area at the exterior edge of the property. It unclear why there was a “Y” connector at this location or if this location was used for pumping directly to the sewer.

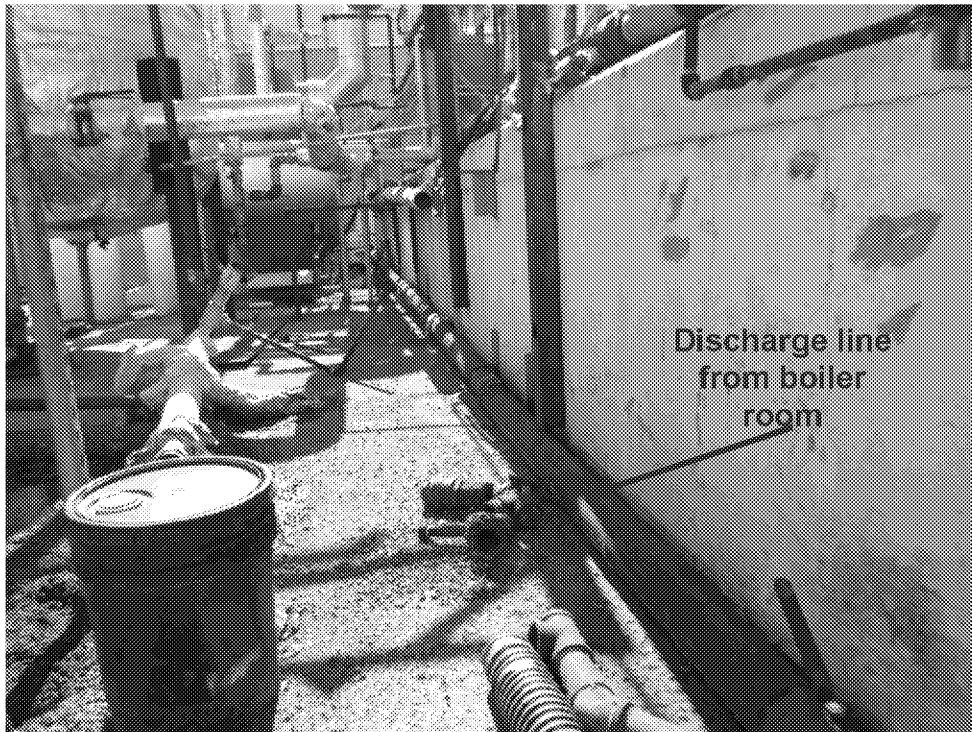
Photograph 10. View of the discharge line depicted in Photograph 8 following the perimeter of the process area.

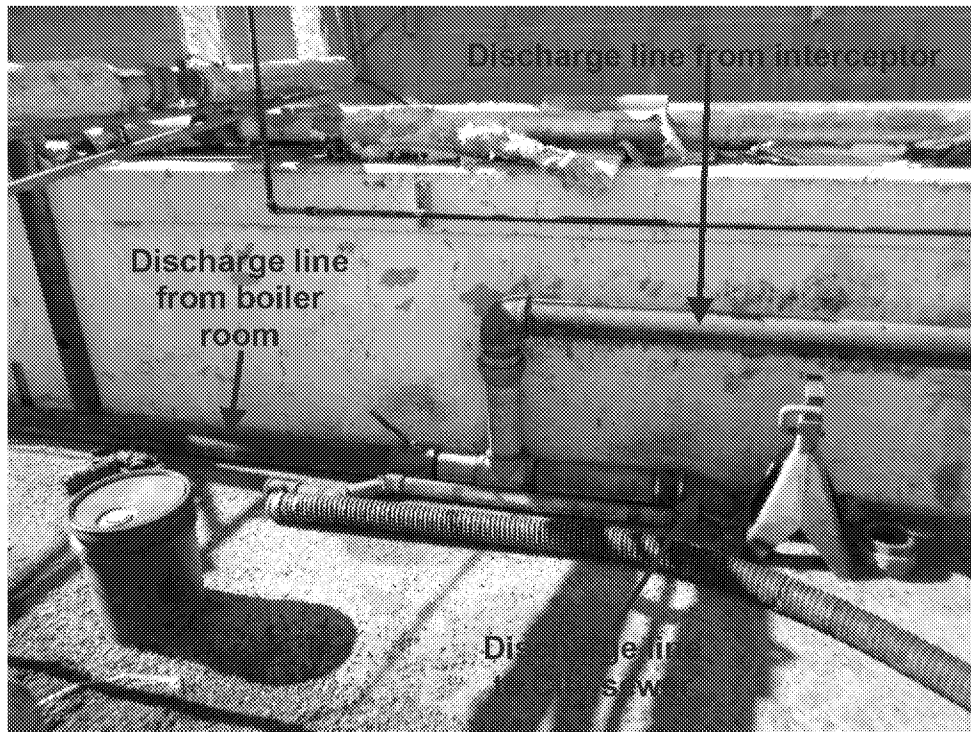
Photograph 11. View of the facility's process discharge lines to the City's sewer system.

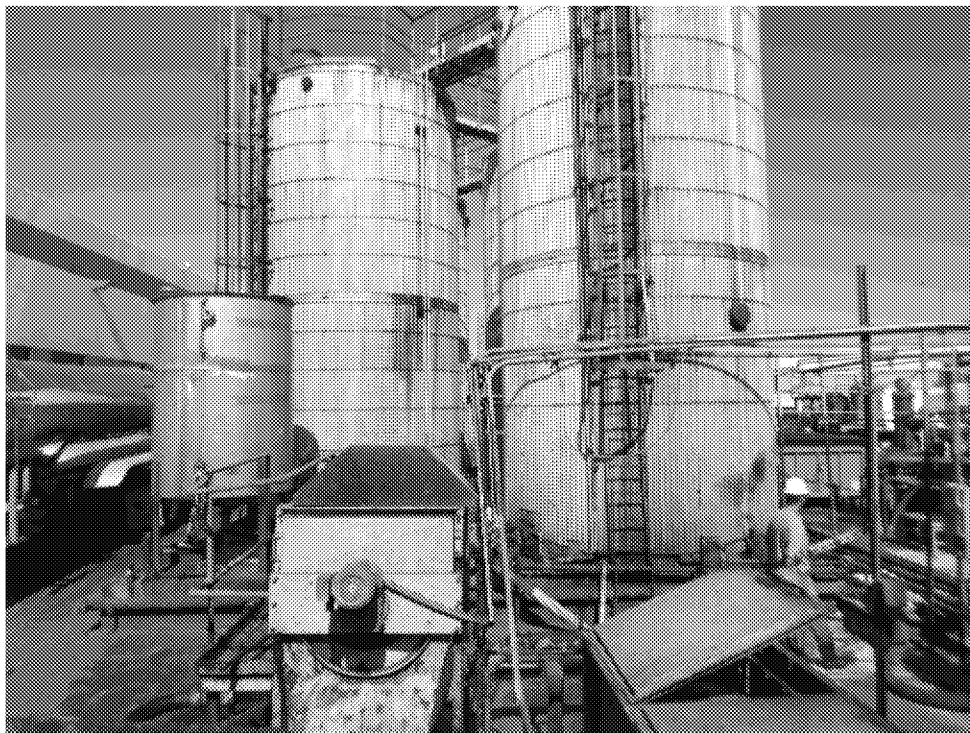
Photograph 12. View of receiving and shipping area for raw and finished grease. The area housed four heated storage tanks (20,000 gallons each) and various equipment for grease processing operations.

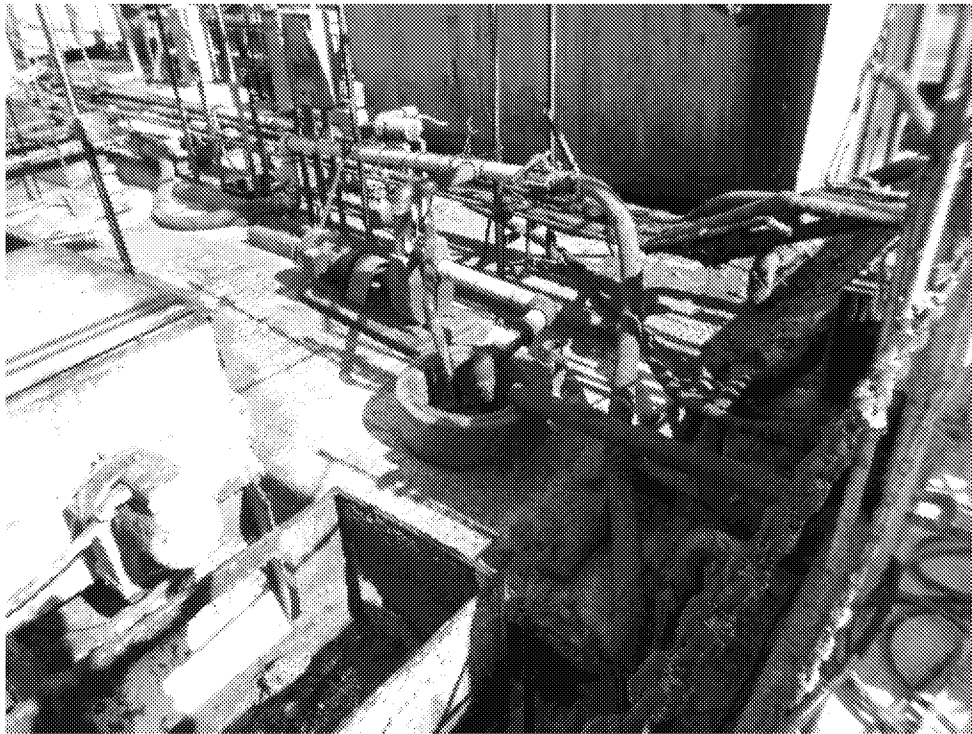
Photograph 13. Example of the network of pipes and hoses used to transport grease throughout the process area at the facility.

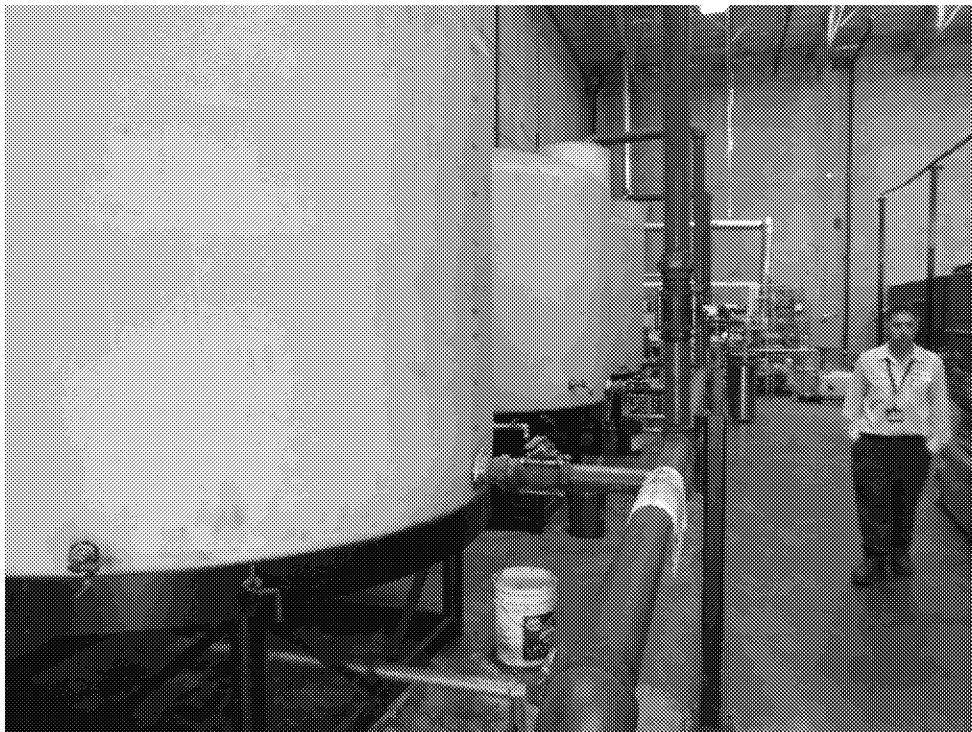
Photograph 14. View of the yellow grease process area, located within the warehouse.

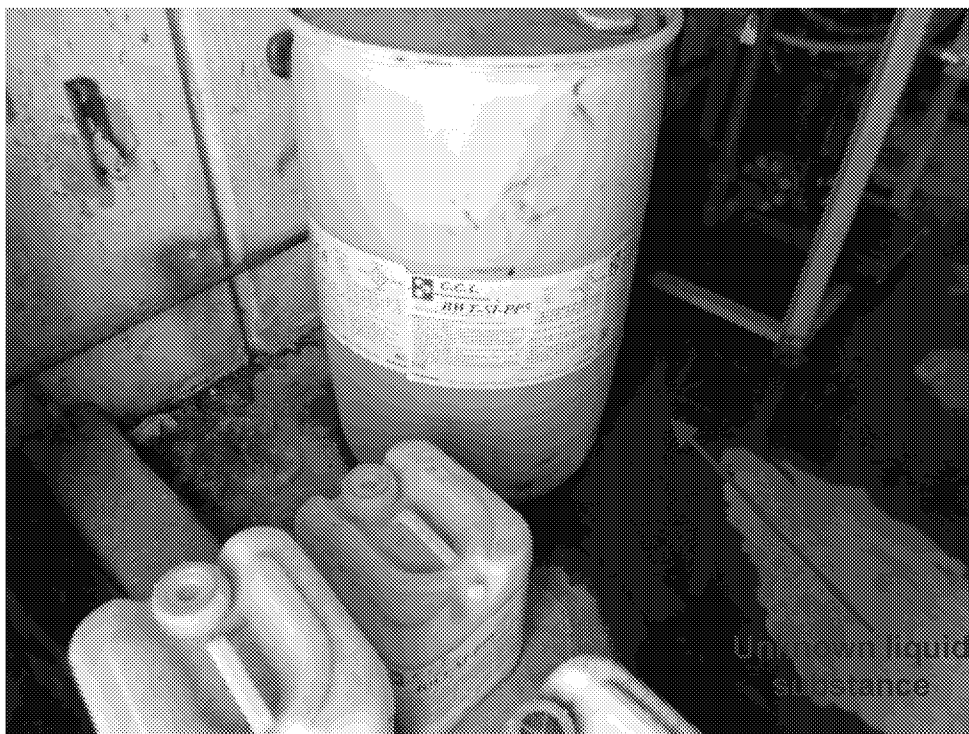
Photograph 15. View of the boiler chemicals stored without secondary containment. Although the liquid on the floor did not omit an odor, the source of the liquid was unknown.

9. The facility’s current operating conditions associated with chemical storage could lead to chemical spills directly to the sanitary sewer. The federal regulations at 40 CFR 403.8(f)(2)(vi) state that the POTW shall “evaluate whether each Significant Industrial User needs a plan or other action to control Slug Discharges.” The EPA Inspection Team was unable to confirm if the facility had been evaluated for the need to develop a slug discharge control plan (SDCP) due to lack of documentation. Due to the uncontained chemical storage area in the boiler room being stored within the direct vicinity of a sewer connection, the City is required to evaluate the need for the facility to develop a SDCP in accordance with the federal regulations at 40 CFR 403.8(f)(2)(vi).

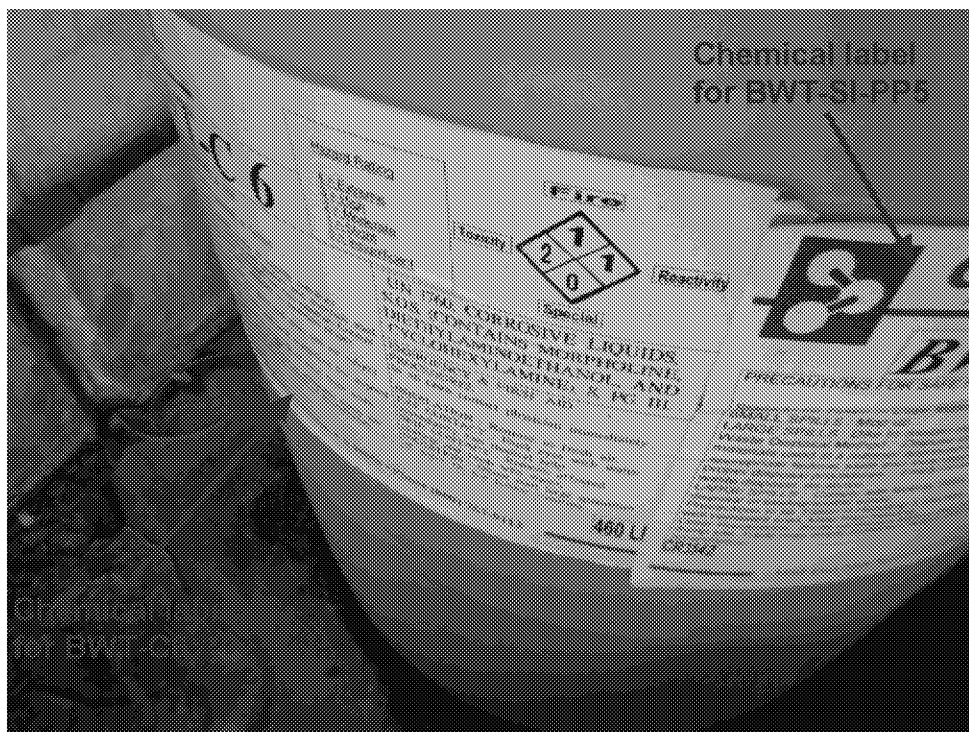
Photograph 16. View of the label on the 55-gallon drum in the boiler room. The drum appeared to have two chemical labels on its side wall: one for BWT-C6 and the other for BWT-SI-PP5. It was unclear to the EPA Inspection Team which chemical was housed in the drum.
